## Test Report

### Testing of products for use in contact with drinking water

Castco LRN : EN0200914-4

Date of Sample Received : 14-09-2020  
Test Period : 18-09-2020 to 24-09-2020  
Brand Name : Pegler  
Manufacturer : Pegler Yorkshire Group Limited  
Origin : UK  
Model No : 141HU FGK  
Specimen No. : BC0200909-012-MISL  
Sample Description : 1/2" Hose Union Bib Tap  
Body Marking : PEGLER

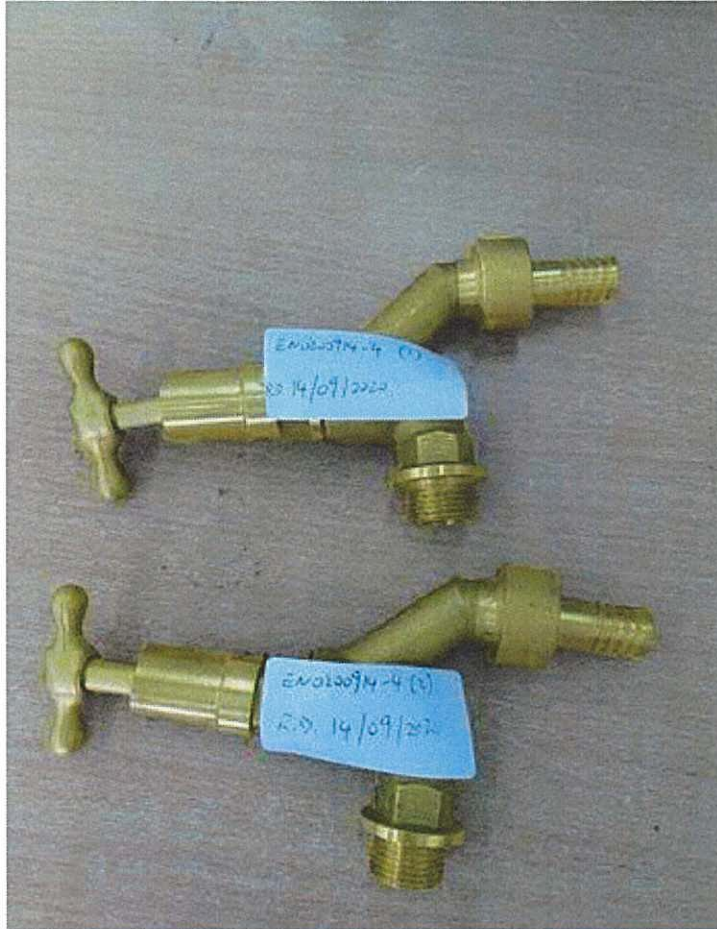
Description of Sample:     1/2" Hose Union Bib Tap
